**CRESTMoor CANYON  
GEOLOGIC AND GEOTECHNICAL INVESTIGATION  
City of San Bruno, California**

for  
**CITY OF SAN BRUNO**  
567 El Camino Real  
San Bruno, California 94066-4299

by  
**COTTON, SHIRES AND ASSOCIATES, INC.**  
330 Village Lane  
Los Gatos, California 95030  
March 2008

**SUBJECT: Geologic and Geotechnical Investigation**  
**RE: Crestmoor Canyon**  
San Bruno, California

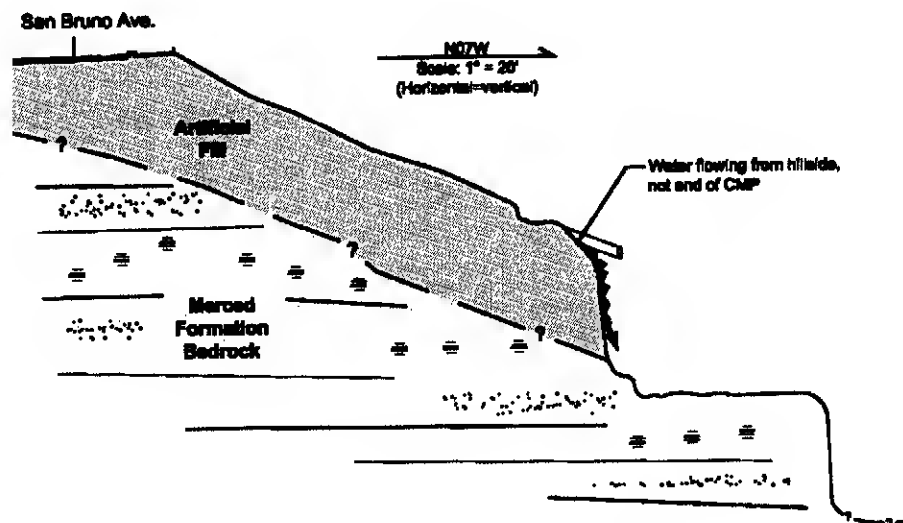
# CRESTMoor CANYON SITE 1

## SAN BRUNO AVENUE FILL SLOPE EROSION AND LANDSLIDING

Fill was placed beneath and on the outboard (downslope) side of San Bruno Avenue between Glenview Drive and Crestmoor Drive, possibly for the construction of San Bruno Avenue. A storm drainage culvert (24-inch $\phi$  CMP) runs underneath San Bruno Avenue and discharges onto the north-facing fill slope, approximately 50 feet downslope of the outboard edge of the road. Storm water discharging from the 24-inch $\phi$  CMP has scoured through the existing fill, exposed the underlying bedrock and created a steep gully incision in the slope up to 20 feet deep. The gully has migrated upslope approximately 10 feet from the end of the existing pipe, leaving 10 feet unsupported. We understand that the problem was previously identified and that storm discharge has been diverted to other conduits. However, we noted during several site visits that some water continues to flow from the culvert. Additionally, the bottom of the CMP has corroded throughout its exposed length, resulting in water draining at the slope/pipe interface. Upslope of the existing incised gully the slope exhibits signs of instability; a scarp, approximately 2 feet high, was observed on the slope south of the existing CMP.

The fill prism supporting San Bruno Avenue has undergone an extensive amount of erosion and continues to erode. Although the majority of the storm run-off has been diverted from this particular culvert a perennial flow of water (variations in volume of flow have not been determined) continues to drain and is contributing to further erosion and slope instability in this area. Fresh scarps are visible upslope of the incised gully. The risk of future enlargement of slope instability and adverse impacts to San Bruno Avenue is **moderate to high** under static or seismic conditions.

We recommend that a temporary flexible pipe and connection be attached to the end of the pipe and discharged at a suitable location downslope. The City should monitor this condition including looking for signs of distress in the roadway and downslope instability. If the City chooses to be proactive, then a focused geotechnical investigation could be completed including detailed surveying of the local slopes. An analysis should be completed to address static and seismic factors of safety against failure. Appropriate mitigation alternatives should be outlined as necessary. The corroded sections of the pipe should either be removed, replaced or lined. (See photos 130-133 on CD showing site conditions)
